May 8, 2015

Re: Structural Safety Assessment of Building 408, Port of Moses Lake  
C No. 150341

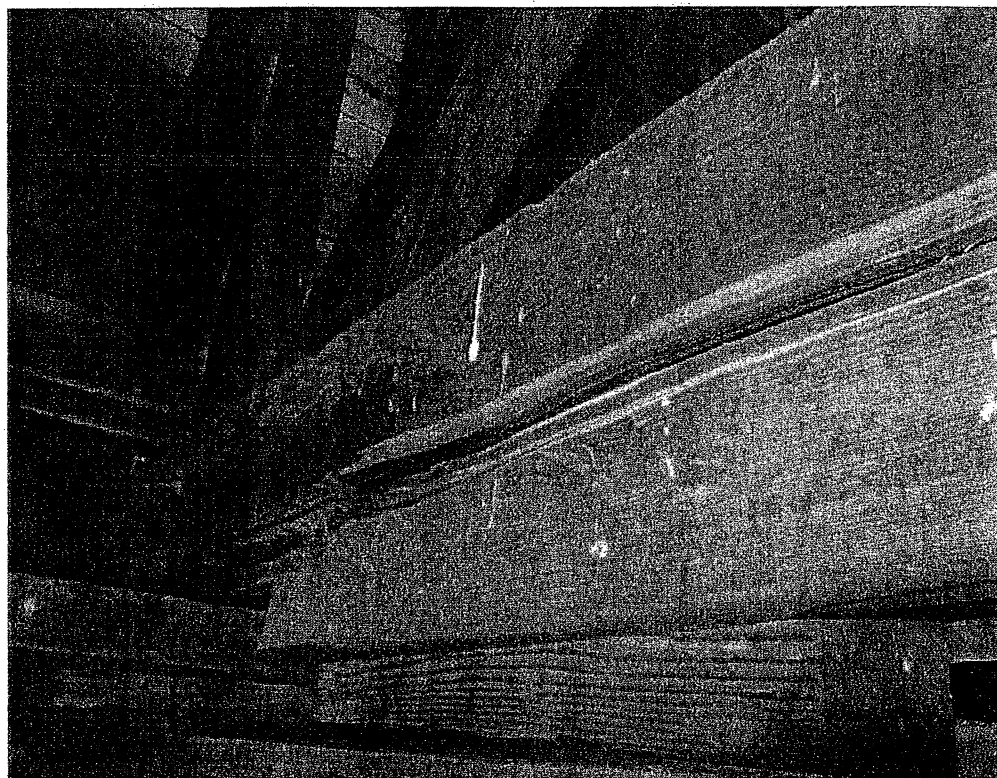
**Photograph No. 1**

Our observations of the existing conditions found the damage of the structure to be continuing to increase. One example of this is the cross-bracing between the south wall and the first interior truss. The following photographs show how large splits in the horizontal struts at the bottom chord level appear to be relatively recent by the fresh color of the wood in the split zones.

This view is looking south in the southeast portion of the building. This split member is the bottom strut associated with the vertical cross-bracing that transfers wind forces into a horizontal truss that spans across the east-west width of the building.

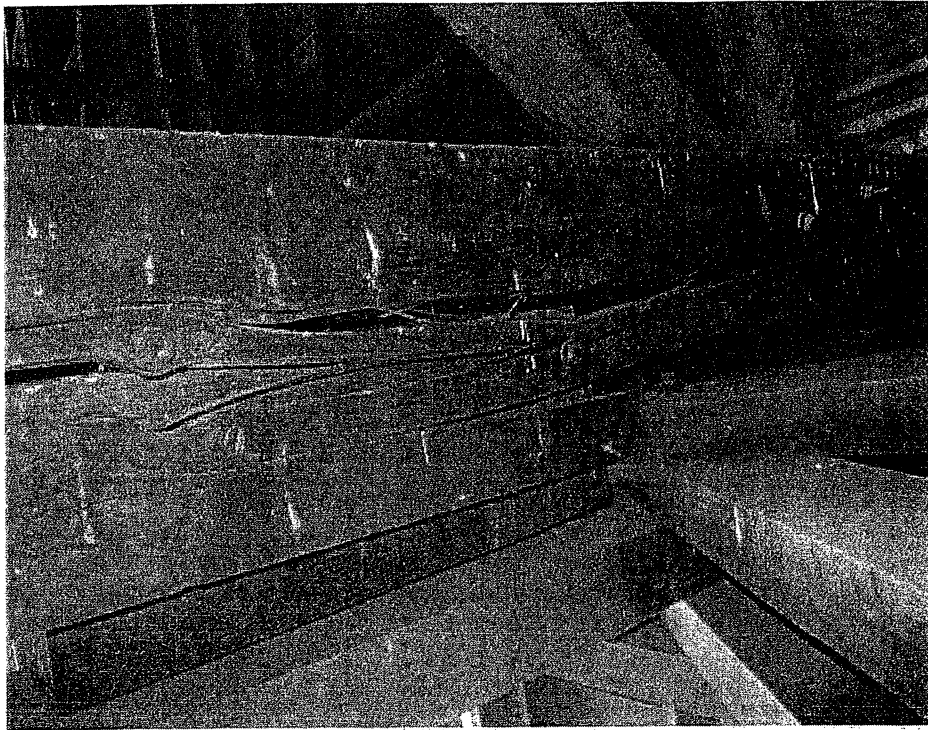
**Photograph No. 2**

This view shows the opposite side of the member in Photograph No. 1.

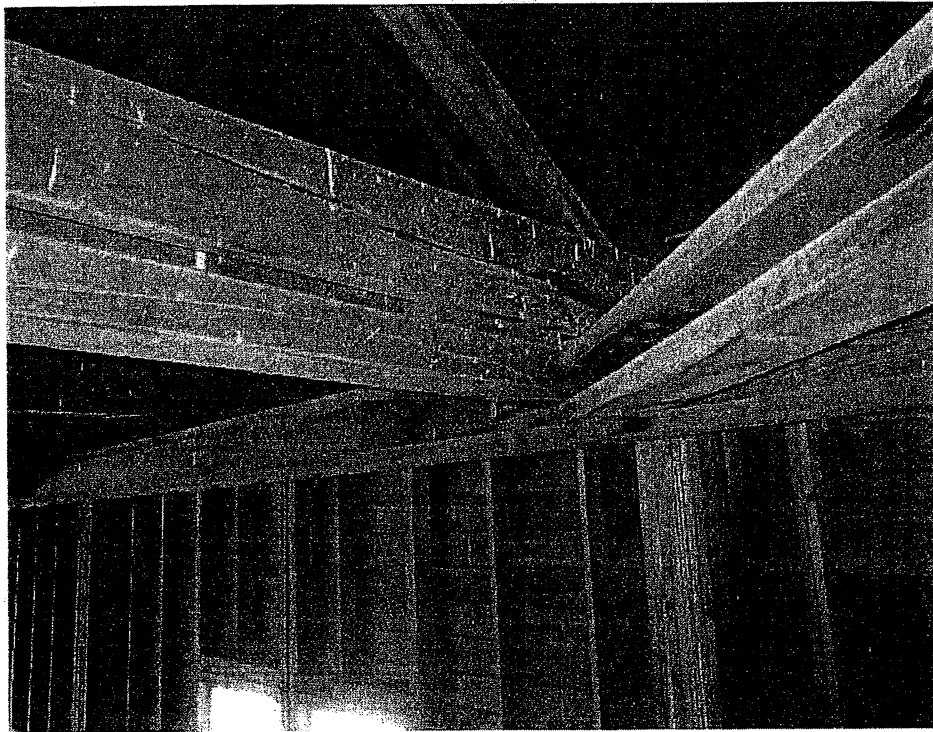
**Photograph No. 3**

This split member wind brace strut is located adjacent to the failed brace shown in Photograph No. 1. The color of the wood in this split looked like the split was recent.

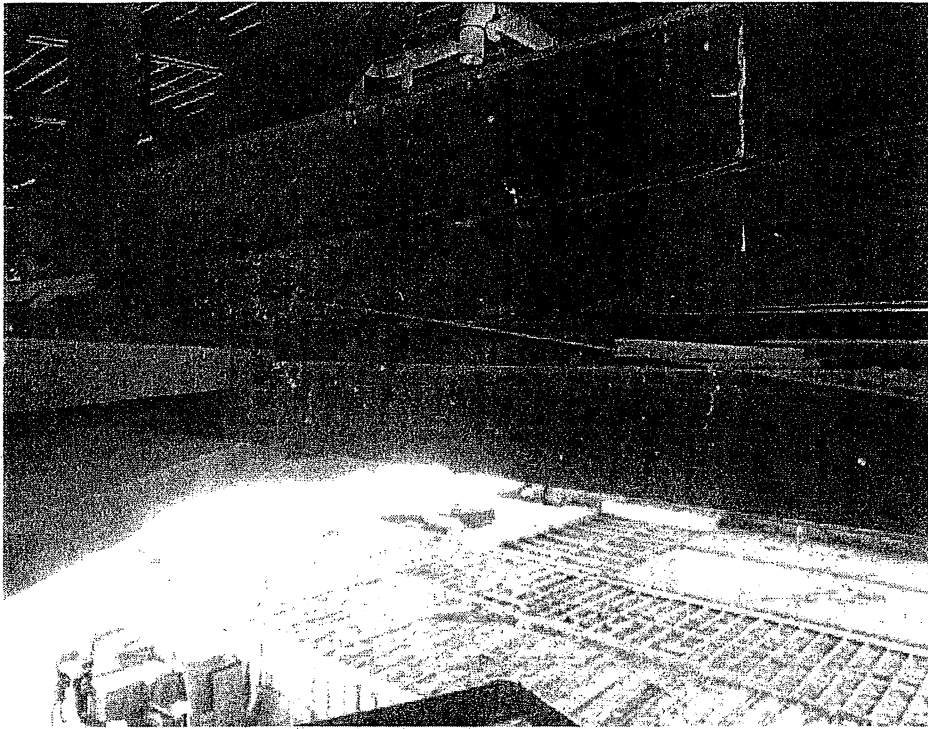
**Photograph No. 4**

This view is looking north and shows the wind struts have splits on both ends.

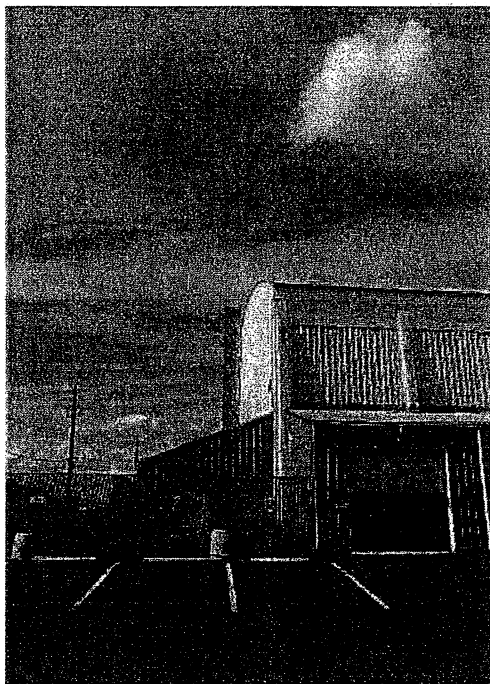
**Photograph No. 5**

This view is looking west along the south end of Building 408. The failed wind bracing shown by the previous photographs braces the top of this south exterior wall.

The failure of this wind bracing is directly related to the lateral movement of the top of the trusses towards the north that is being monitored by a plumb line. The roof decking is made up of one inch thick boards that are installed perpendicular to the roof purlins that span between the trusses. This system is not a rated diaphragm and provides only nominal lateral wind load restraint. This situation is an example of secondary building elements that are currently helping to hold this building together but normally are not permitted to be the primary structural system.

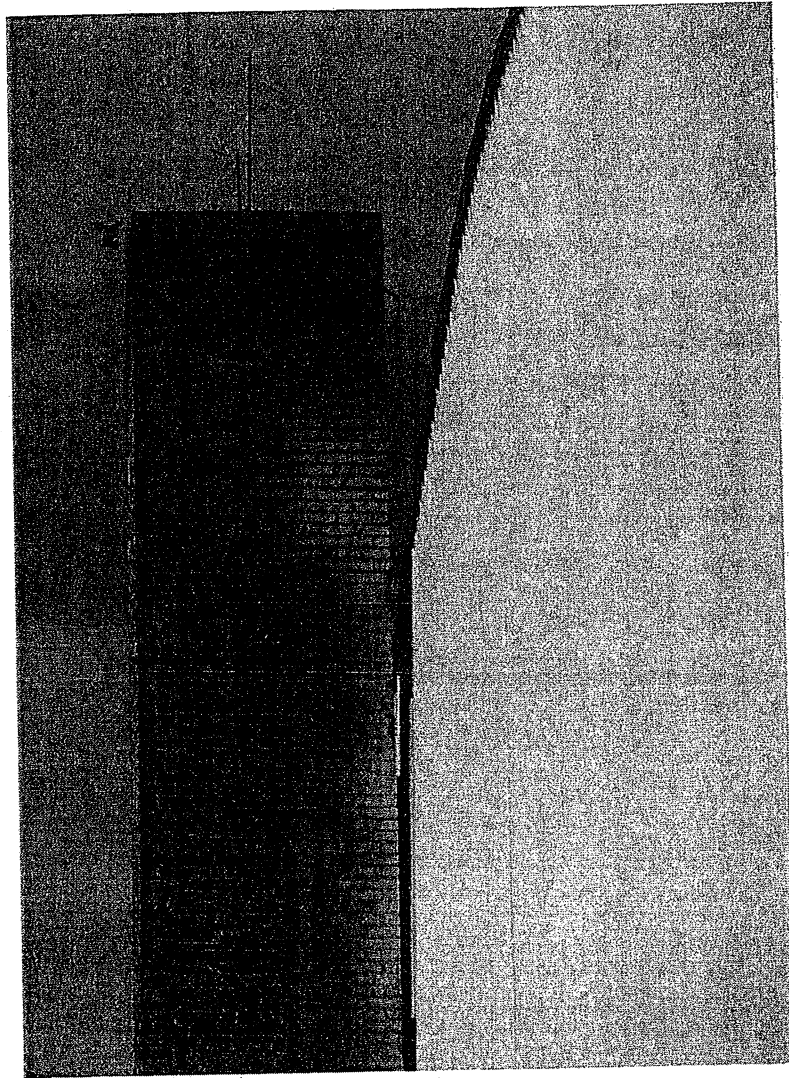
**Photograph No. 6**

This view shows how the top of the south wall has moved several inches towards the north resulting in a gap between the brick chimney and the wall.
