PORT OF MOSES LAKE

Preliminary Condition Assessment & Structural Evaluation of Building 401 Primary Roof Structure

Jacobs Engineering Group, Inc.

June 15, 2012
Jacobs Project # W3X63800

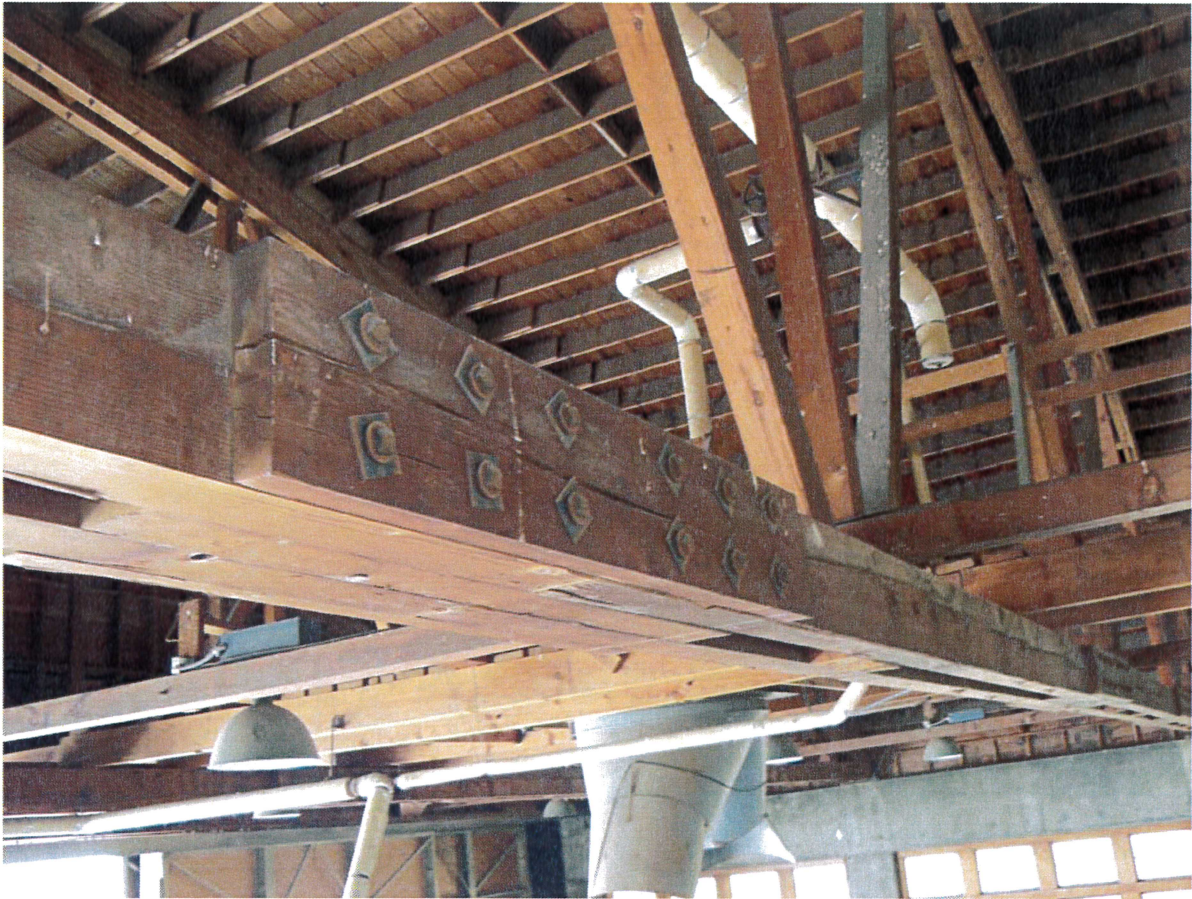
Bow string truss bottom chord main members	Deep splits extend throughout the length of the splice region in close lateral proximity to the split rings at numerous locations. At several locations the split length apparently extends the entire length of the main member (approximately 20feet).	Crack and checks were observed at many locations throughout truss bottom chord members.
Bottom chord truss split summary	Observed splits in Trusses A –G.	Observed splits in Trusses B –G.
Bow string truss heel anchor bolts to concrete connection	Not observed due to lack of access.	Several loose anchor bolts observed.
Bow string truss lateral deflection of top and bottom chord	Lateral deflection observed at bottom chord is judged to be insubstantial. No top chord lateral deflection observed.	Observed “S” shaped configuration at both top and bottom chords.
Bow string truss “X” bracing	Observed racking between Truss A and B and Truss F and G.	Observed racking between Truss A and B and Truss F and G.

Checking in Bottom Chord (entire 20' length of board)

In our opinion adding steel rods, plates, and/or channels along the full length on each side of the bottom chord, is a viable repair alternative if the top chord glue is found to be adequate. This will increase the vertical load capacity of the trusses to current code load levels. Additionally, we recommend further investigation and evaluation of the existing roof structure's lateral and uplift capacities during the final design.

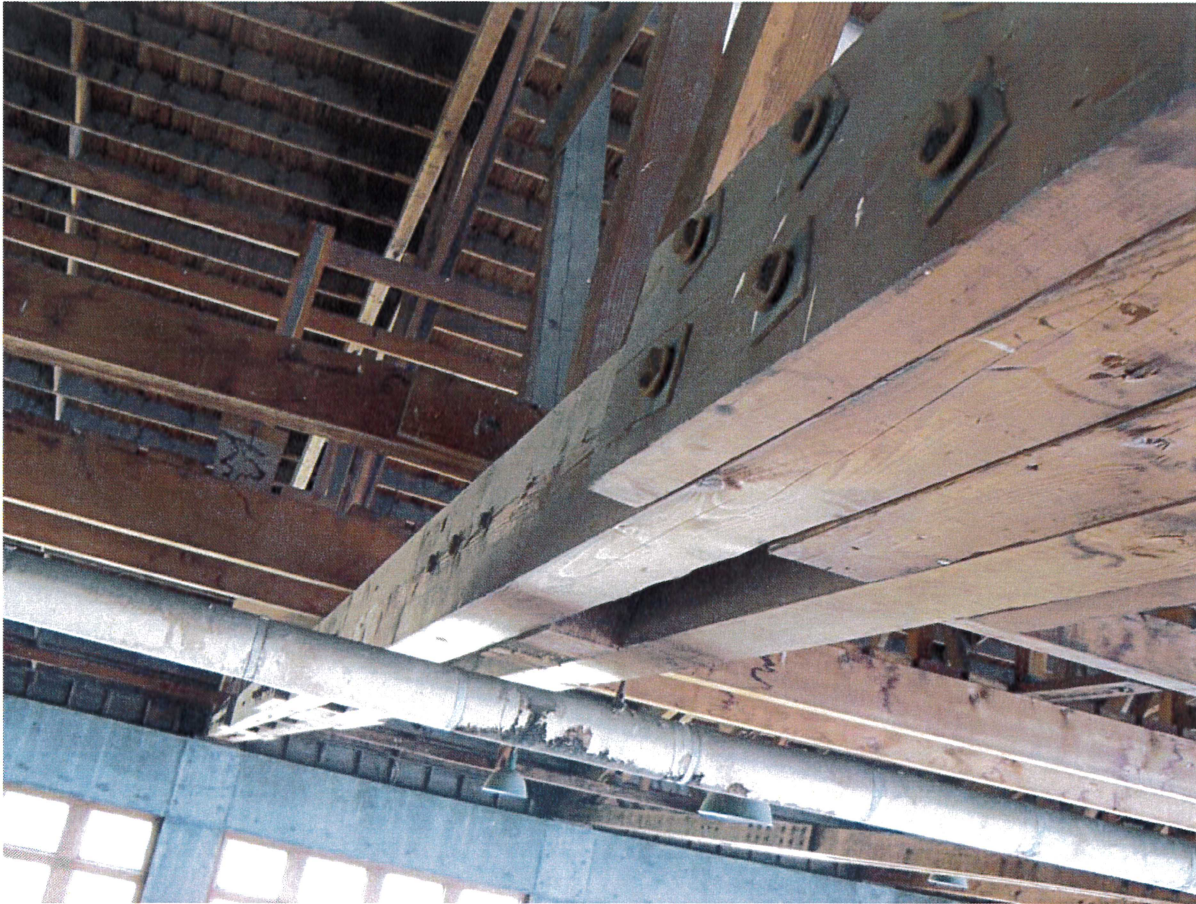
Longitudinal Splitting of Bottom Chord

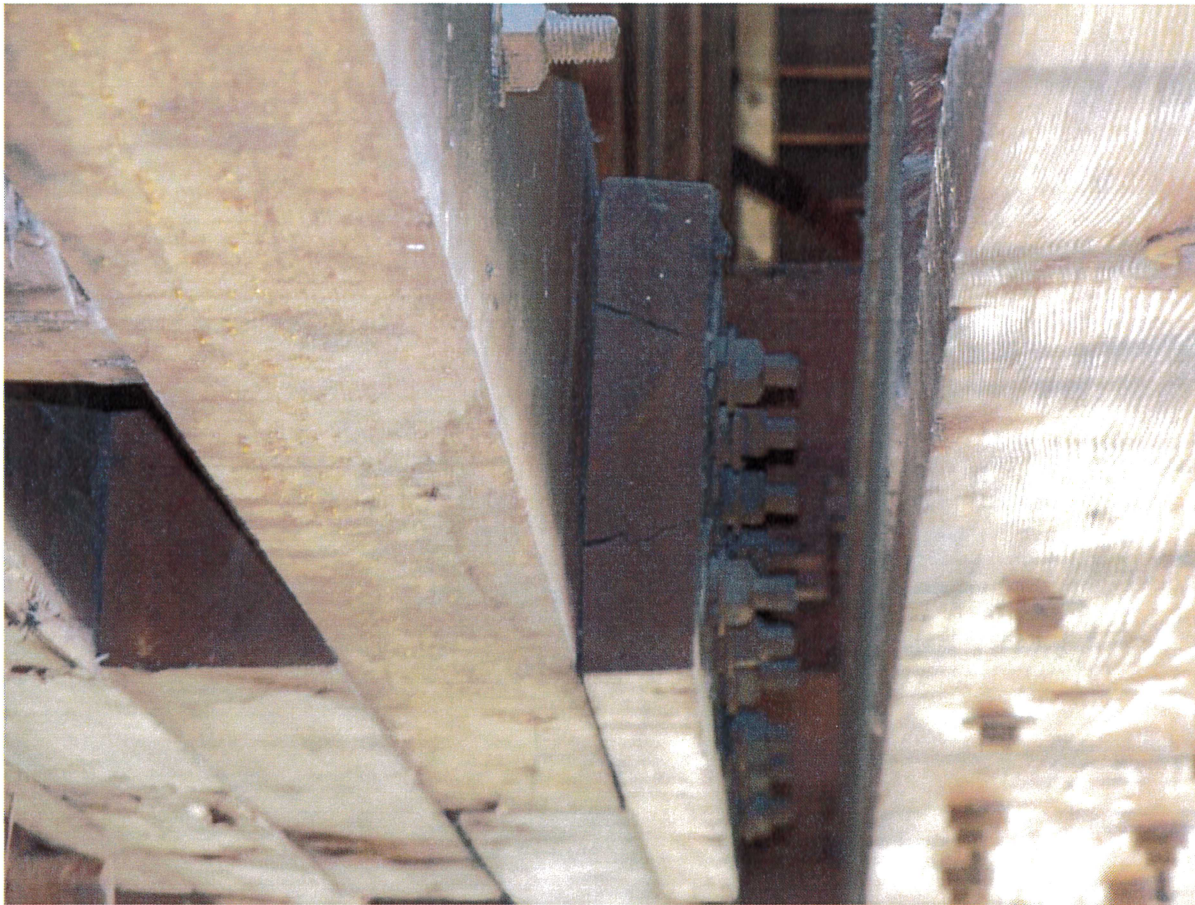
The PE&D report indicates that the bowstring trusses are adequate to support the required live load, if in good condition. However, there is extensive splitting of the bottom chord and splice plates and loose bolts, which leads to an elevated risk that the normal snow load could cause the chord to fail and potentially lead to a collapse of the entire roof structure.

Splitting Through Splice Plates

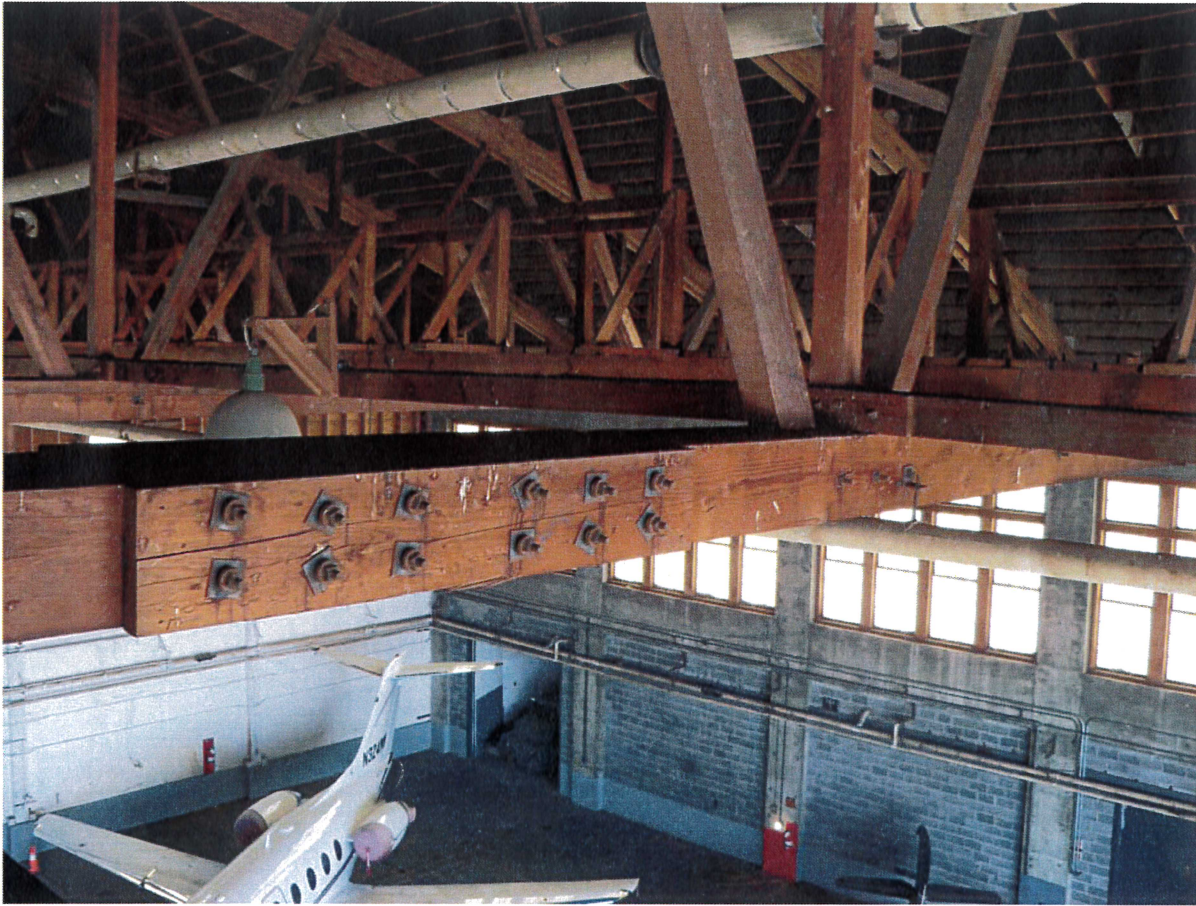
More splice plate splitting

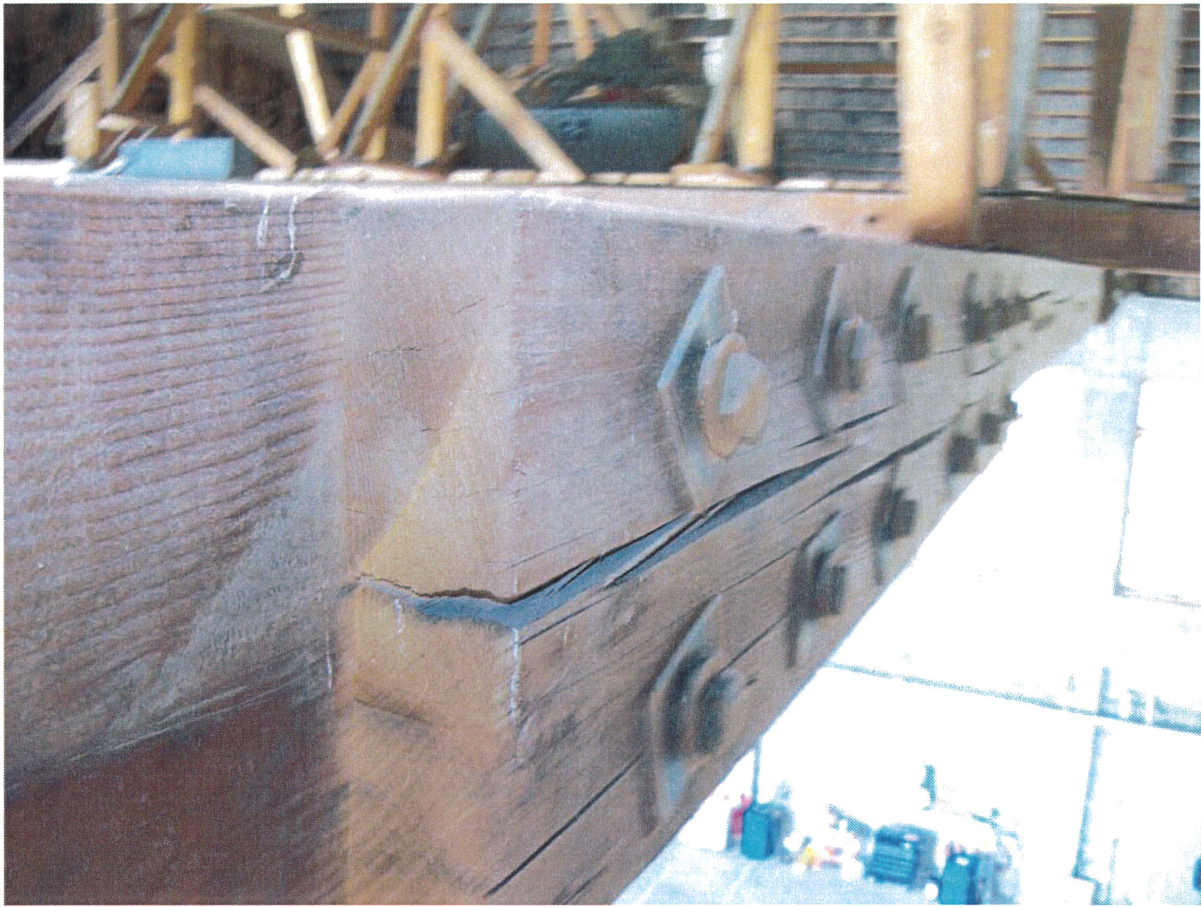
More Splice Plate Splitting

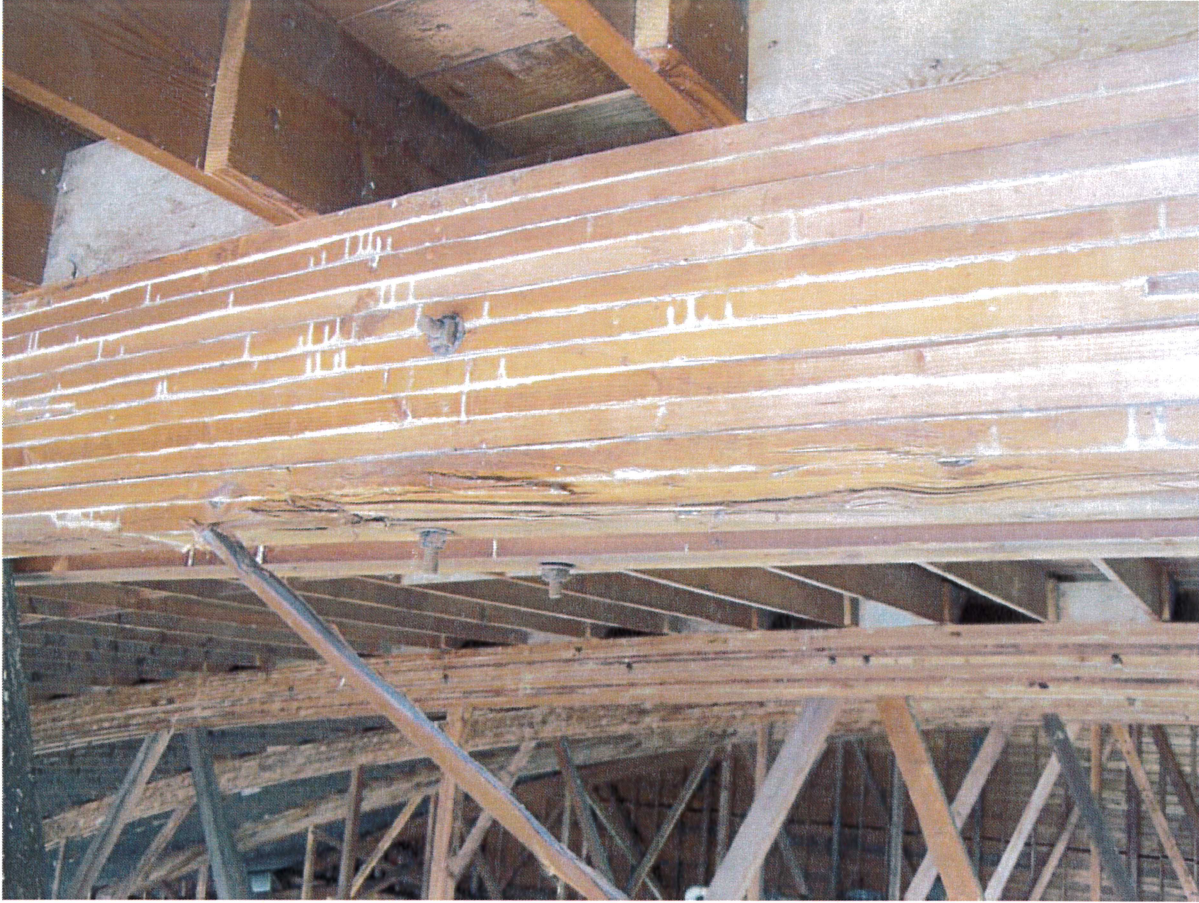
- 2) Although the top chord stresses appear adequate to resist roof loads, the residual strength of the glue is questionable. Reduced glue adhesion strength could potentially degrade the top chord capacity. We recommend that the glue be evaluated to determine if the top chords have adequate capacity before any repairs are undertaken.

Damaged top chord

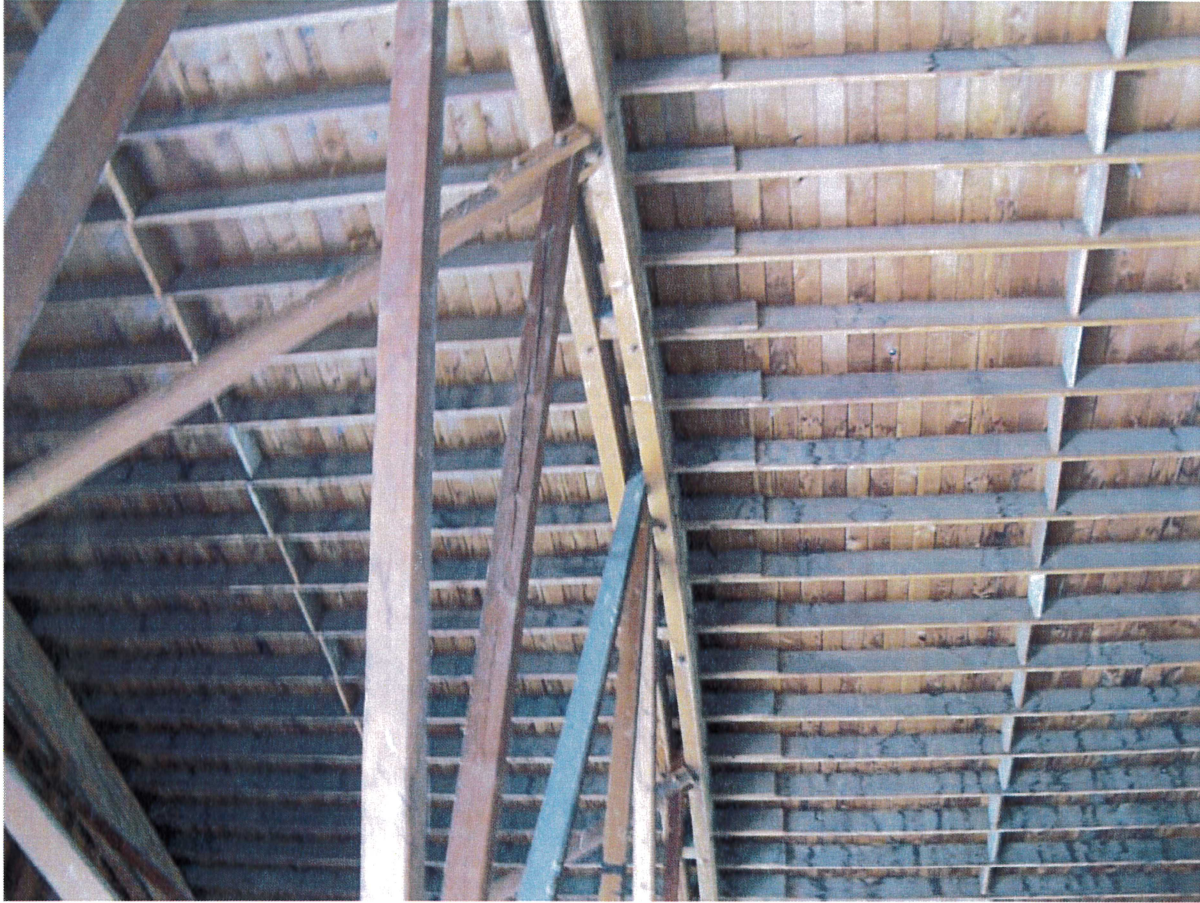
Split diagonal

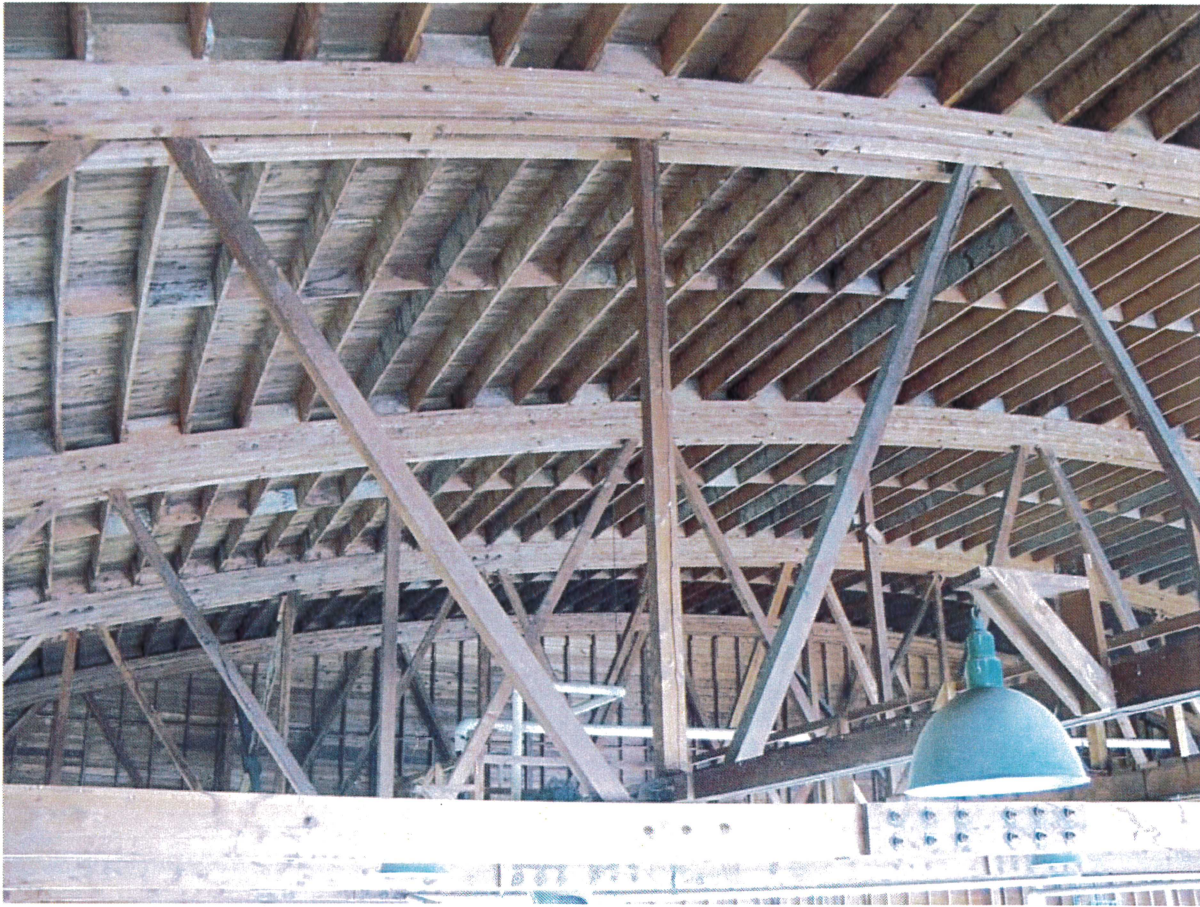
Additional Split Diagonals

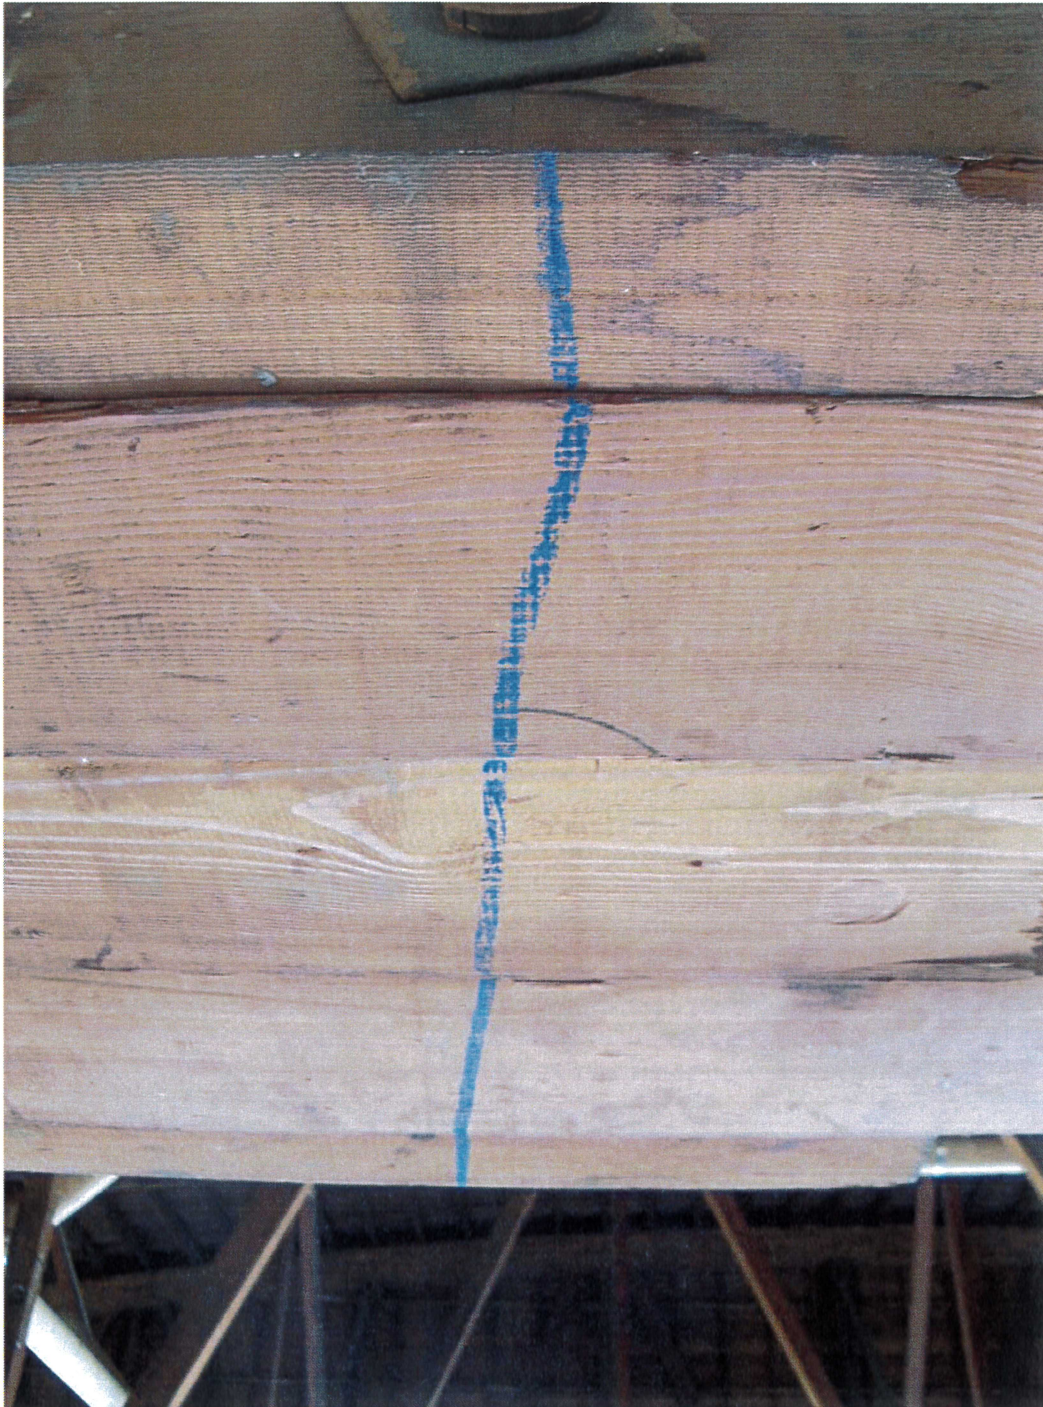
Possible Splice Plate Movement

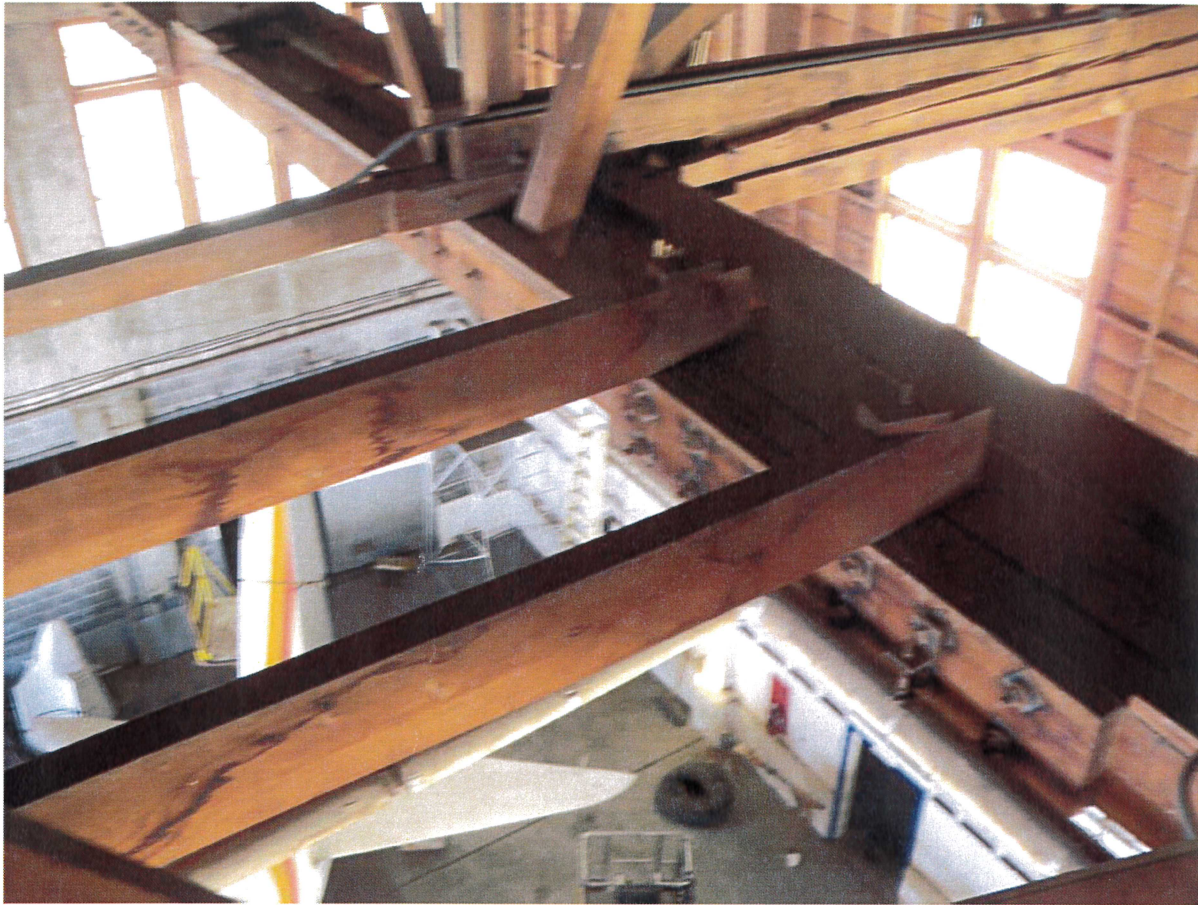
Our review further indicates that portions of the lateral support system have failed due to broken "X" bracing and cracked wind struts, which has degraded the lateral capacity of the building.

The PE&D report also indicates that the lateral system has failed as evidenced by racked and broken "X" bracing, cracked wind truss struts, and other related failures.

Broken Lateral Bracing

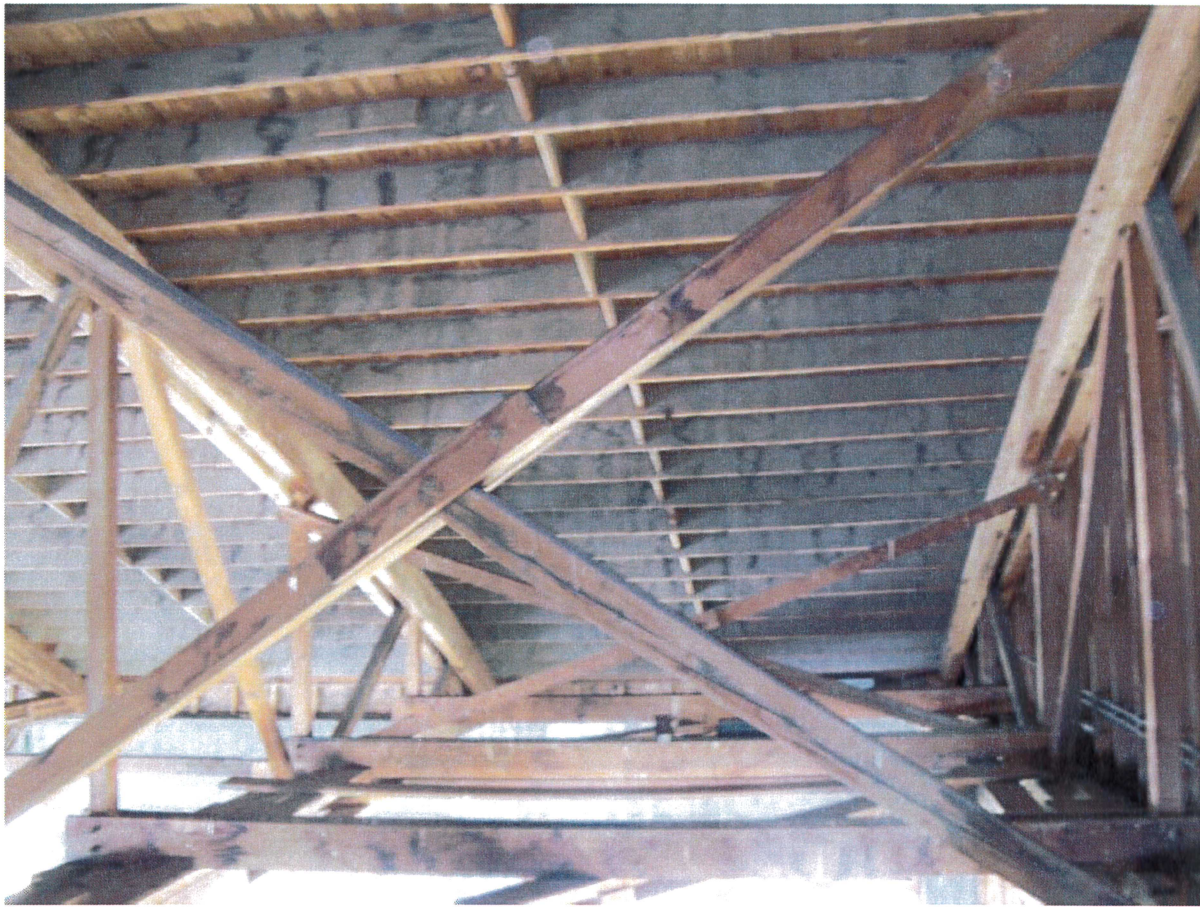
Racked and split lateral bracing

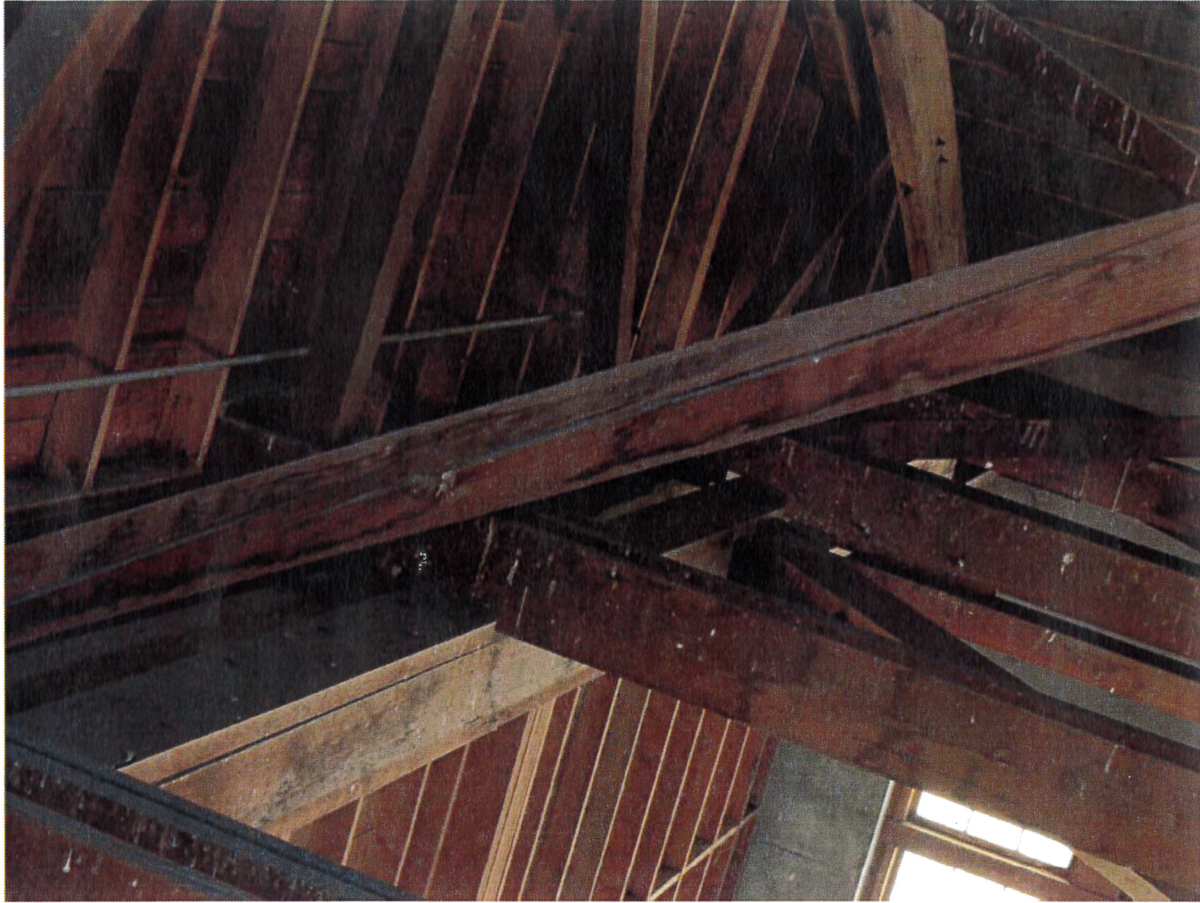
More split lateral bracing
